# **Debris/Ice/TPS Assessment and Integrated Photographic Analysis of Shuttle mission STS-104**

Armando Oliu  
Process Engineering/Mechanical System Division/ET-SRB Branch,  
Kennedy Space Center, Florida

**July 12, 2001**

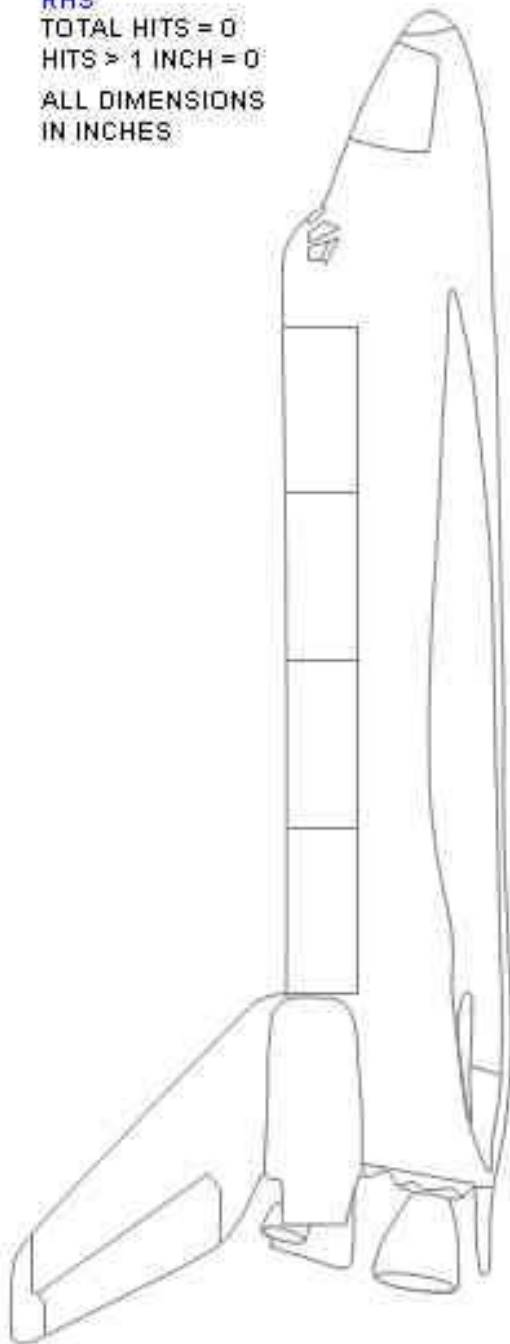
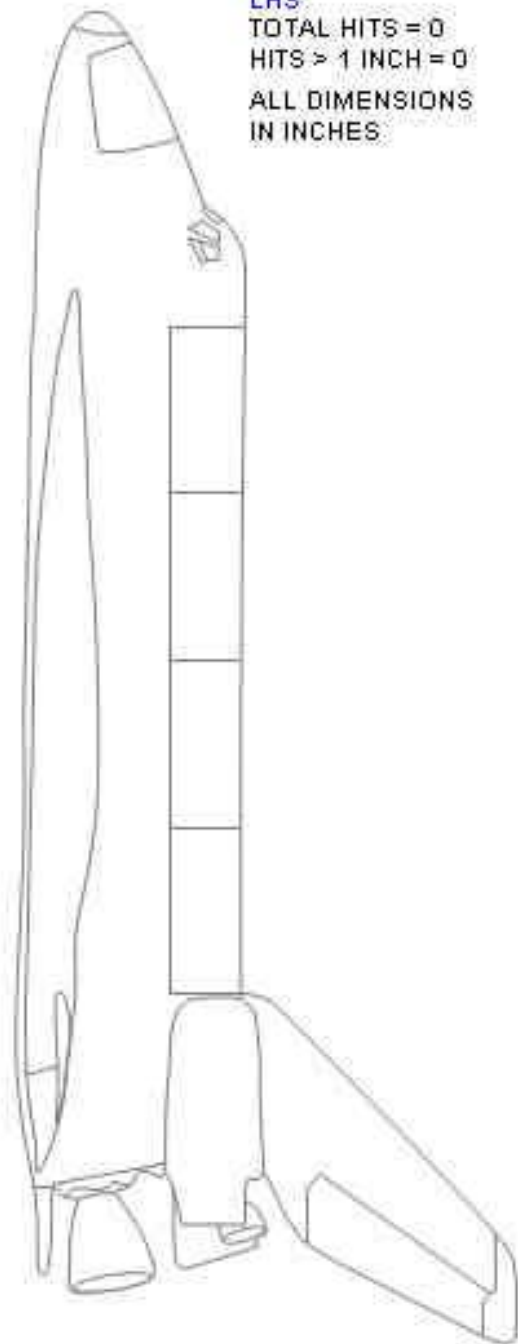
**Figure 3: Overall View of Orbiter Sides**

**RHS**  
TOTAL HITS = 0  
HITS > 1 INCH = 0  
ALL DIMENSIONS  
IN INCHES

**LHS**  
TOTAL HITS = 0  
HITS > 1 INCH = 0  
ALL DIMENSIONS  
IN INCHES

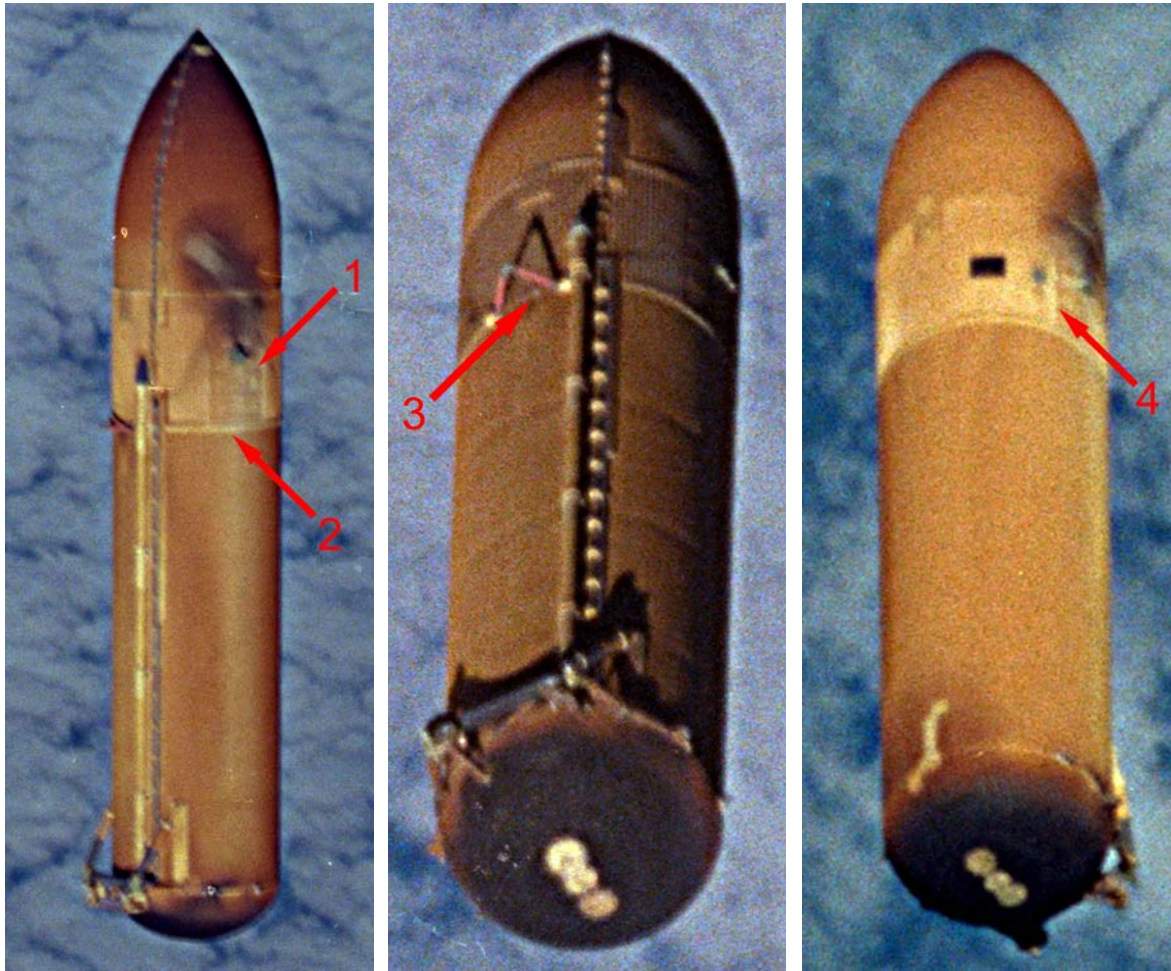
Figure 2.3.3 Crew Handheld Images of the External Tank (frames 3, 18, 29)

Several light-colored marks were seen on the +Y thrust panel TPS aft of the RSRB / ET forward attach. See figure 2.3.3, annotation 1. These light-colored marks may be areas of divots but are more likely to be sanded areas that were present prior to launch. A very faint, light-colored mark that may possibly be a divot was seen on the +Y LH2 tank-to-intertank closeout flange. See figure 2.3.3, annotation 2. A light-colored mark that may possibly be a divot was seen on the

LH2 tank-to-intertank closeout flange between the legs of the ET / Orbiter forward attach bipod. See figure 2.3.3, annotation 3. Light-colored marks on the -Y edge of the -Y thrust panel appeared to be sanded areas that were present prior to launch. See figure 2.3.3, annotation 4. The normal SRB separation burn scars and aero-heating marks were noted on the intertank and nose TPS of the ET. The LO2 tank / Ojive TPS appeared to be in good condition at the level of detail that could be resolved on this film.

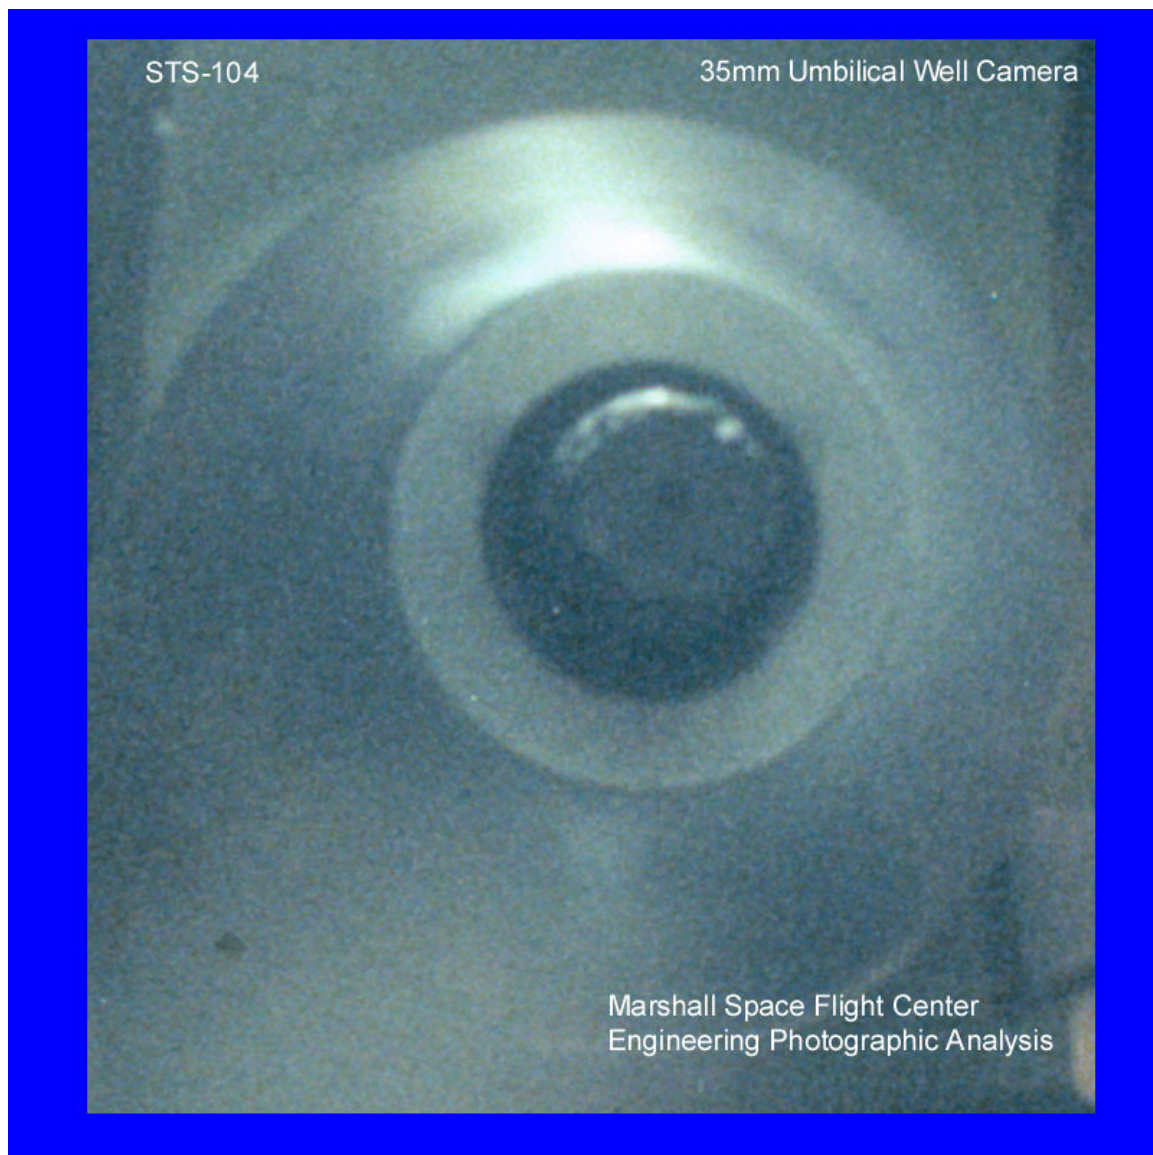
**Figure 12. Close-up of the EO-3 Separation Bolt**

A close-up view of the EO-3 separation bolt.
